R1245 Rev 0 October 2019 **City of Bayswater Bayswater 2019 Foreshore Inspection** & 10 Year Priority Plan

K1673, Report R1245 Rev 0 Record of Document Revisions

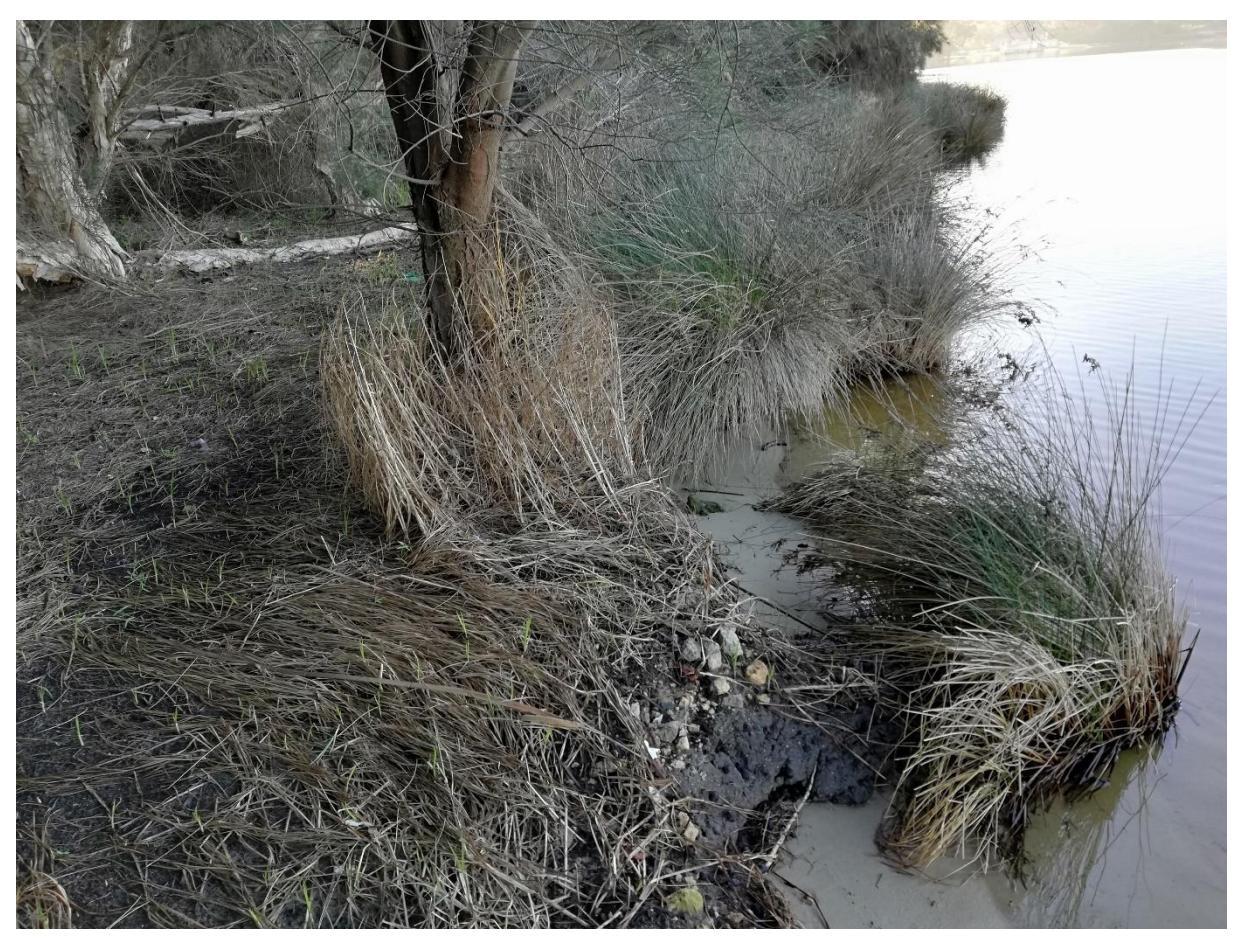
Figure 2.2 Silt Overlaying Sands at the Shoreline West of Bardon Park

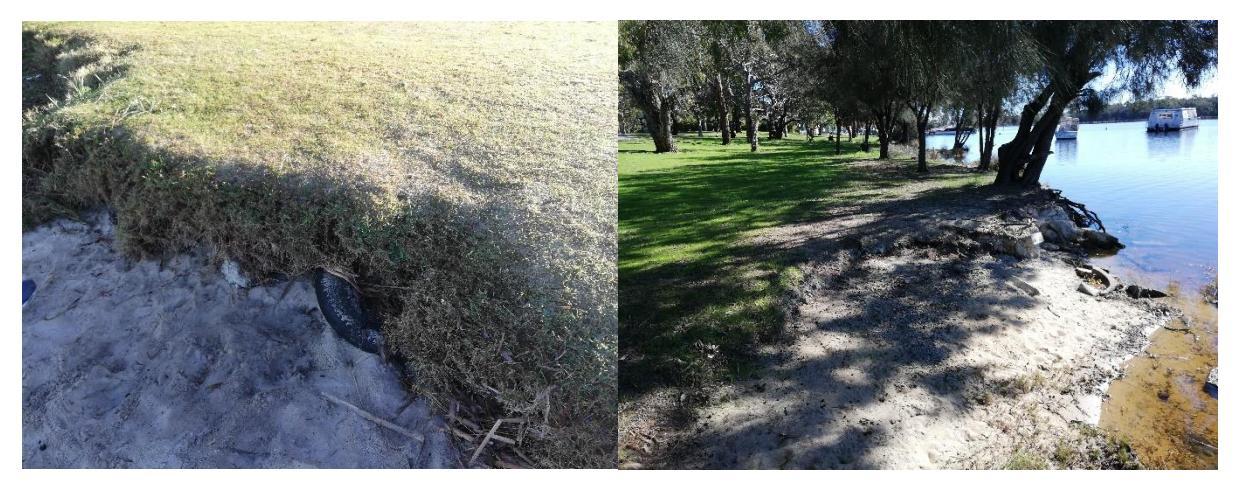
Figure 2.3 Uncontrolled Fill at Berringa Park (left) & Tranby Reserve (right)

The search did not identify any Registered Contaminated Sites intersecting the City's foreshore. However, the ground conditions are noted to be "contaminated" with rubble and debris, including concrete, rocks and bricks. This is evidence of uncontrolled fill.

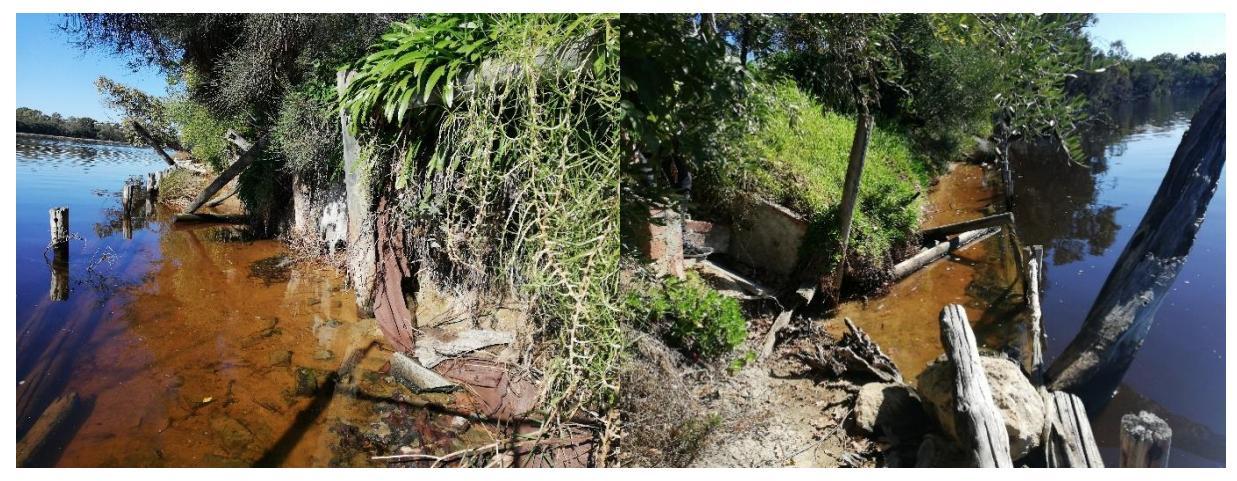
The Tranby House Reserve timber walling has a combined rating of 25. The critical rating means that actions are recommended within 1 year.

The timber walling is in very poor condition, with many beams falling away from the structure. Sand has recently been placed between the wall and the riverbank. The wall was holding some this material in place at the time of the inspection.

An approximately 1.5 m high vertical scarp exists landward of the wall and the riverbank above this scarp is steep. Trees on the riverbank are growing outwards at an approximately 45-degree angle towards the river. Two sets of stairs providing access to the shoreline are damaged. Warning signage is in place along the path to access the northern stairs, however both sets of stairs remain easily accessible.

Figure 5.1 Failed Tranby House Reserve Timber Walling

The timber walling was previously inspected in 2014 and the structure had failed at this time. The inspections recommended urgent repairs be carried out to the timber walling. It does not appear that any repair works have been completed since 2014.

Figure 5.3 indicates that a revetment or riverwall would be an appropriate stabilisation option. MRA recommends the foreshore stabilisation at the Tranby Reserve North Timber Walling include:

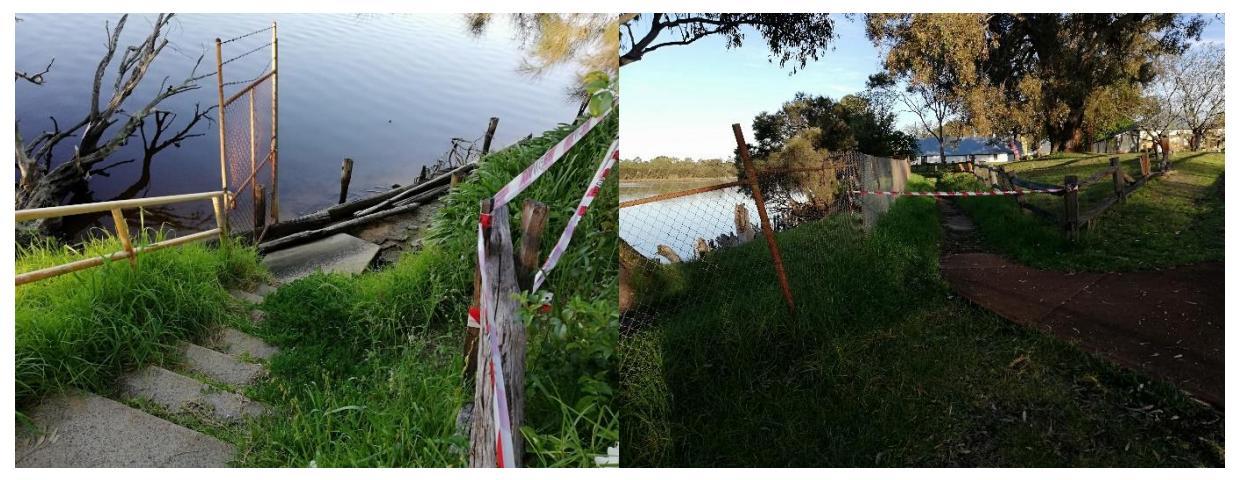
Figure 5.2 Tranby House Reserve Damaged Stairs & Warning Tape

Due to the erosion and the damage, the stairs present an unacceptable risk to public safety. The warning tape currently in place is not a sufficient barrier to the public. **MRA recommends the stairs are closed and appropriate barricading is installed to prevent public access.**

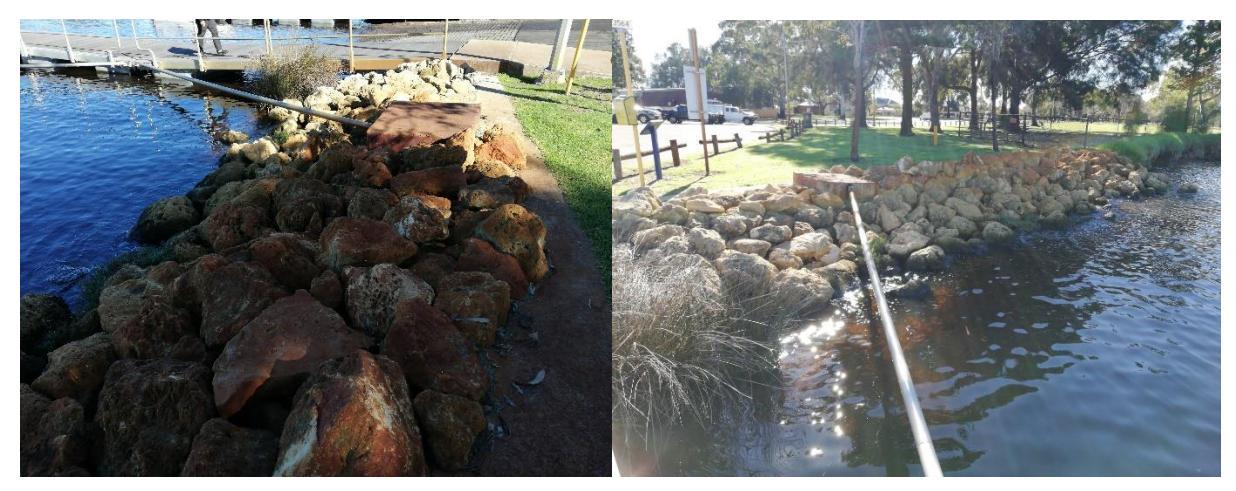
The rock revetment is in average condition. Slumping is evident and the armour rocks generally appear smaller than what would be expected for a revetment with this level of exposure to boat wake. An anchor block for the floating jetty is located at the crest of the revetment. Continued slumping of the revetment may compromise the stability of the anchor block and potentially cause it to fail.

Figure 5.4 Maylands Reserve Rock Revetment

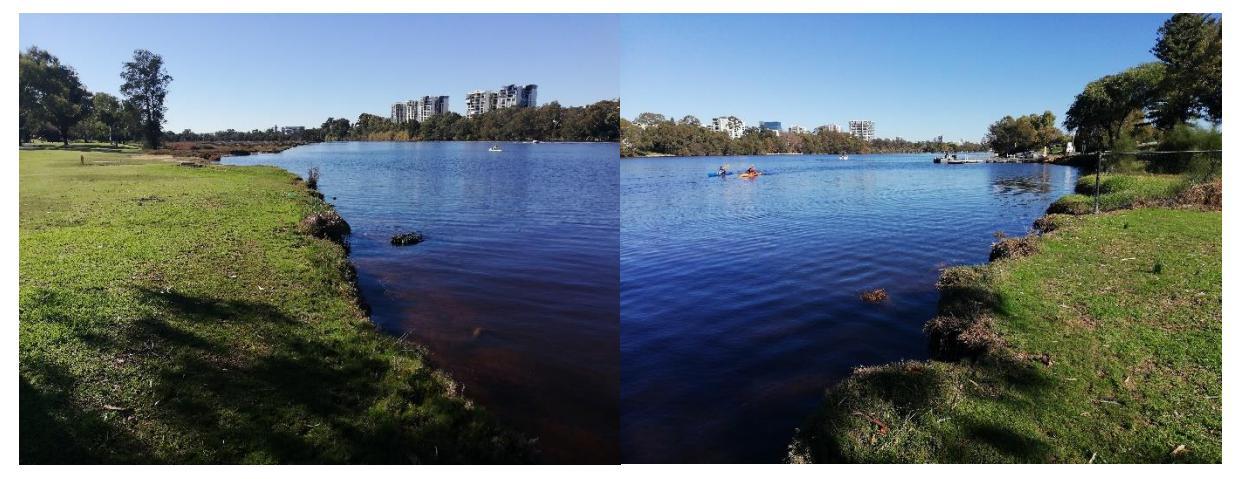
Up to approximately 10 m of erosion has occurred since 1995. This erosion is likely to continue if shoreline stabilisation is not implemented. MRA has recently provided the City with a design for stabilisation and rehabilitation of the shoreline. It is understood that this will be implemented within the short term.

Figure 5.5 Maylands Reserve Natural Shoreline

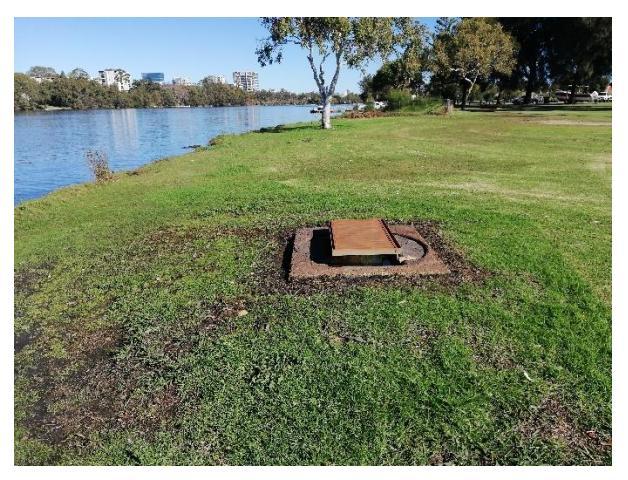
Figure 5.6 Maylands Reserve Drainage Asset Natural Shoreline

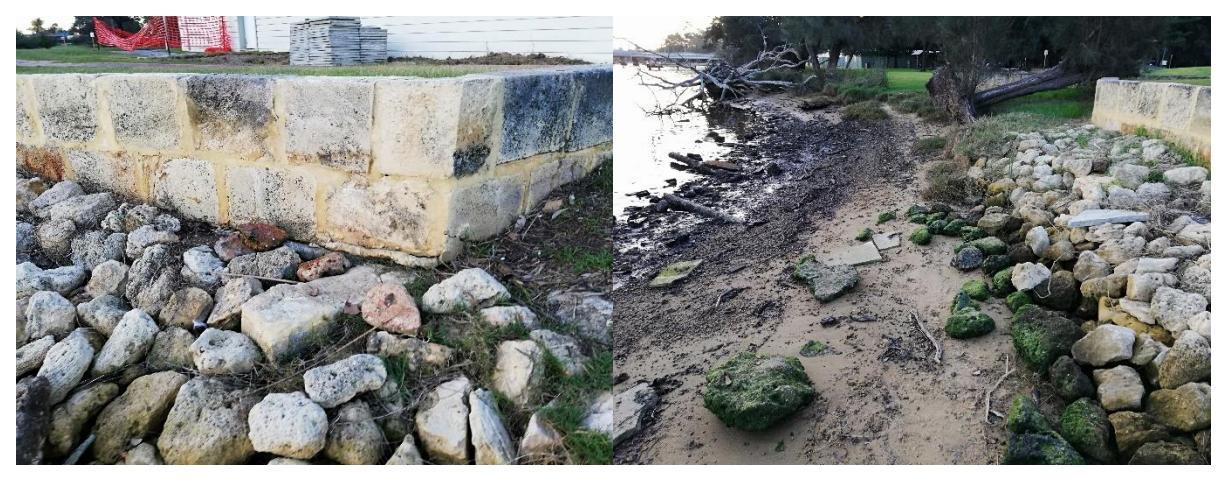
Figure 5.7 Block Wall in front of Sea Scouts Hall

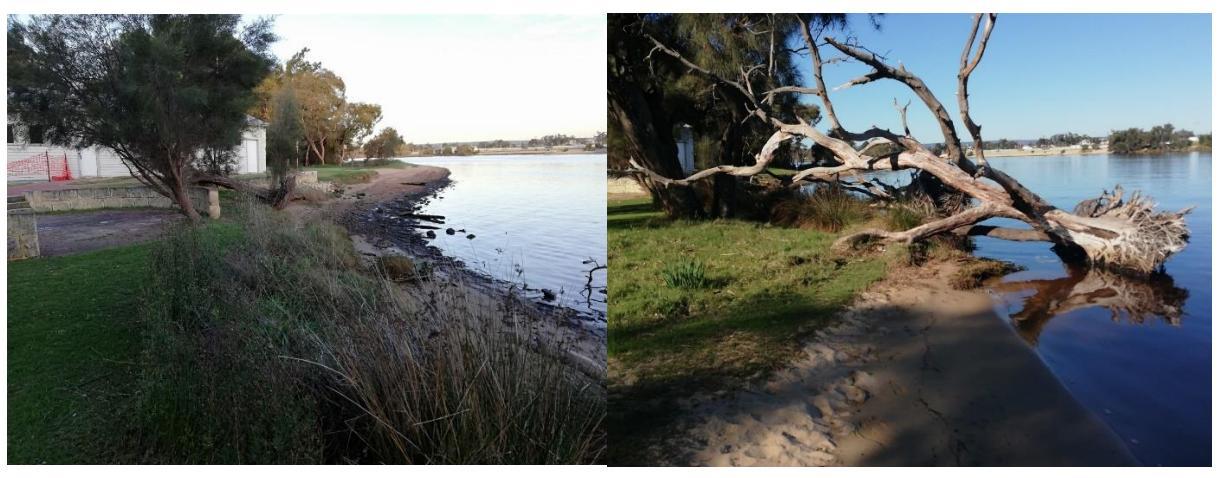
Figure 5.8 Sandy Shore in front Sea Scouts Hall

In addition to stabilisation, MRA recommends that the City consider removing the rubble and debris from the shoreline in front of the Sea Scouts Hall.

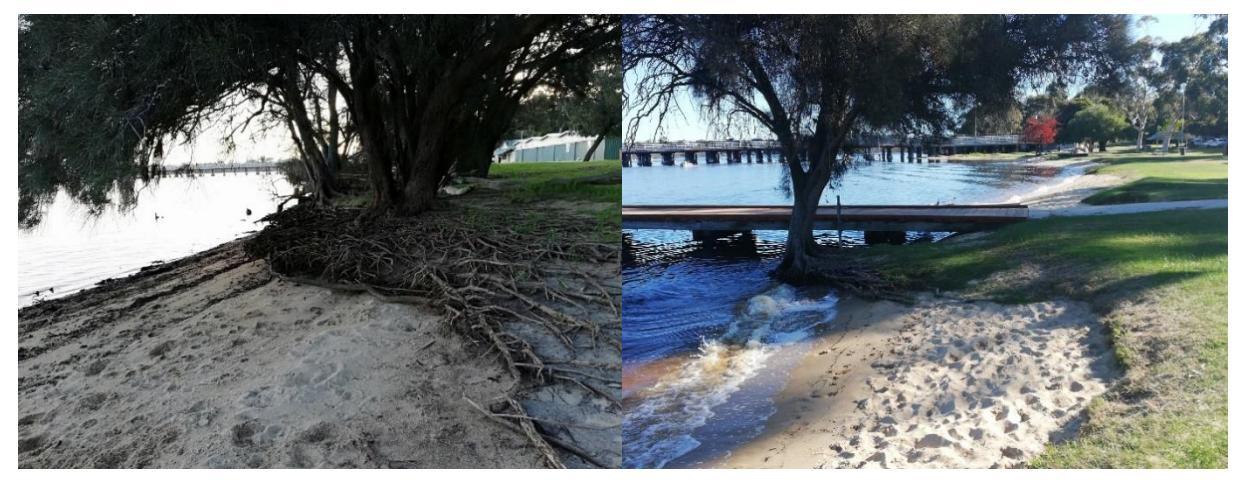
The shoreline at Hinds Park to the west of the Rowing Club was in average condition, with generally no immediate cause for concern. However, erosion has reduced the width of turf between the playground sand pit to less than 1 m. This will require management in the short term.

Figure 5.9 Undercut Trees Adjacent to Rowing Club Jetty

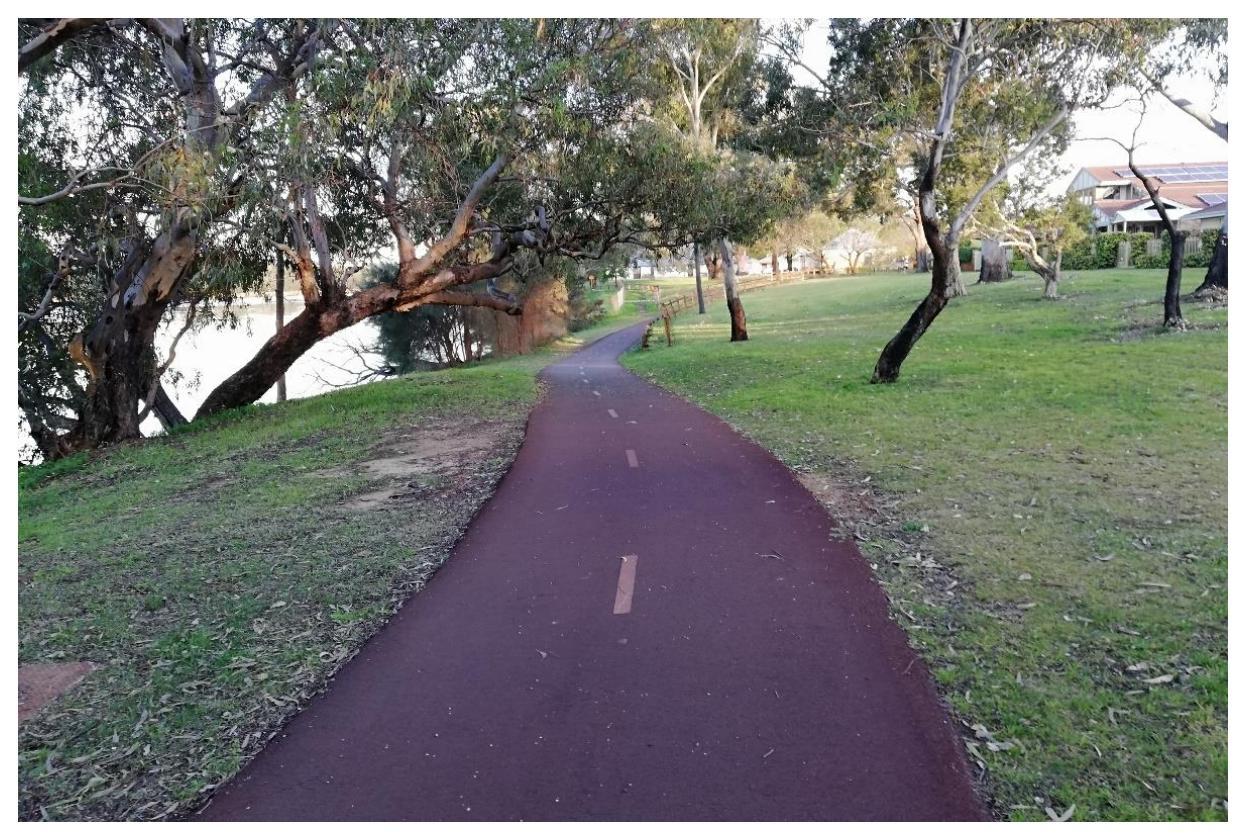
Figure 5.11 Low Footpath & Apartment Buildings to the West of the Footpath

MRA recommends managed retreat in this location. This will require relocation of the footpath further inland. This may also require relocation of drainage and other assets.

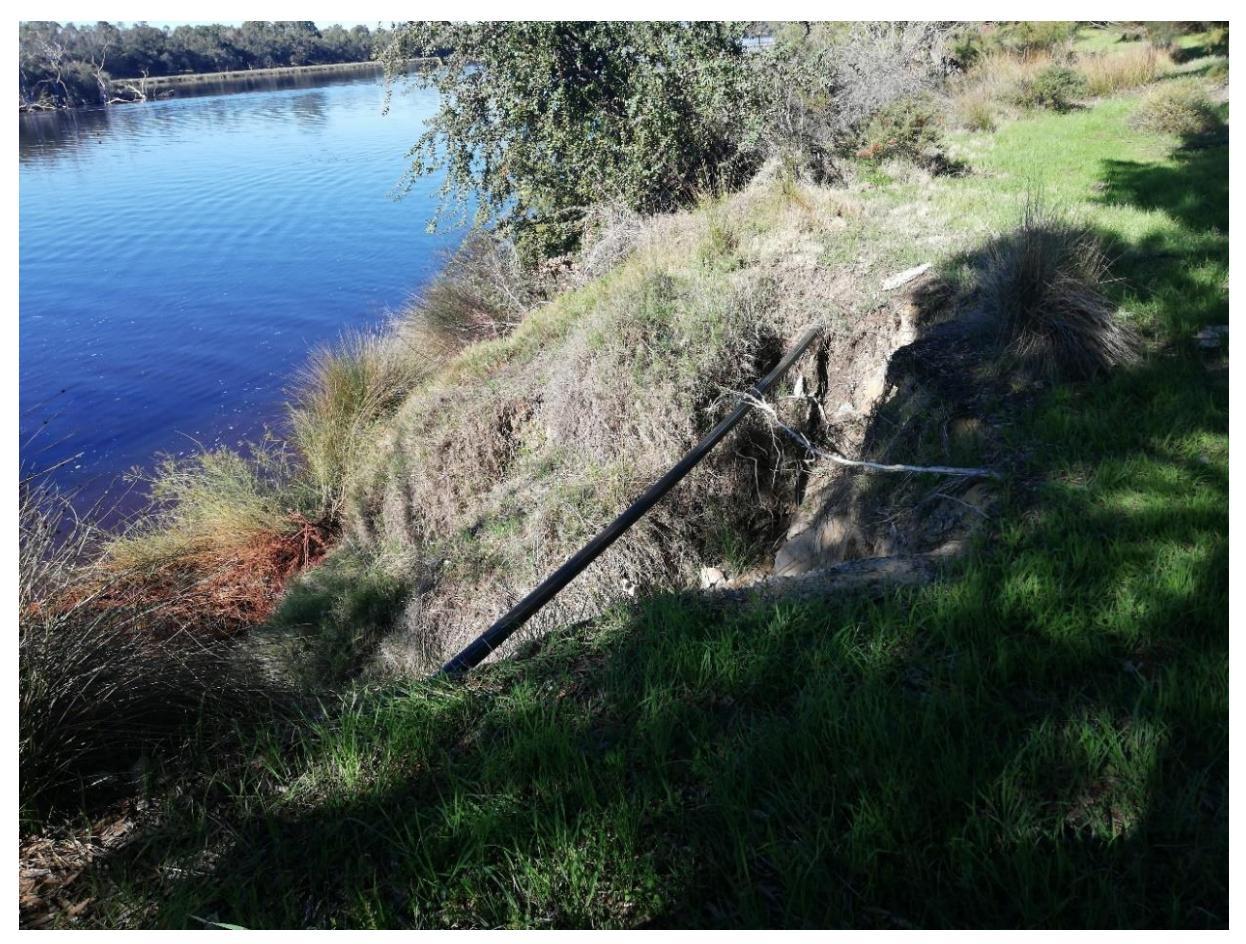
Figure 5.12 Eroded Riverbank & Exposed Water Corporation Asset

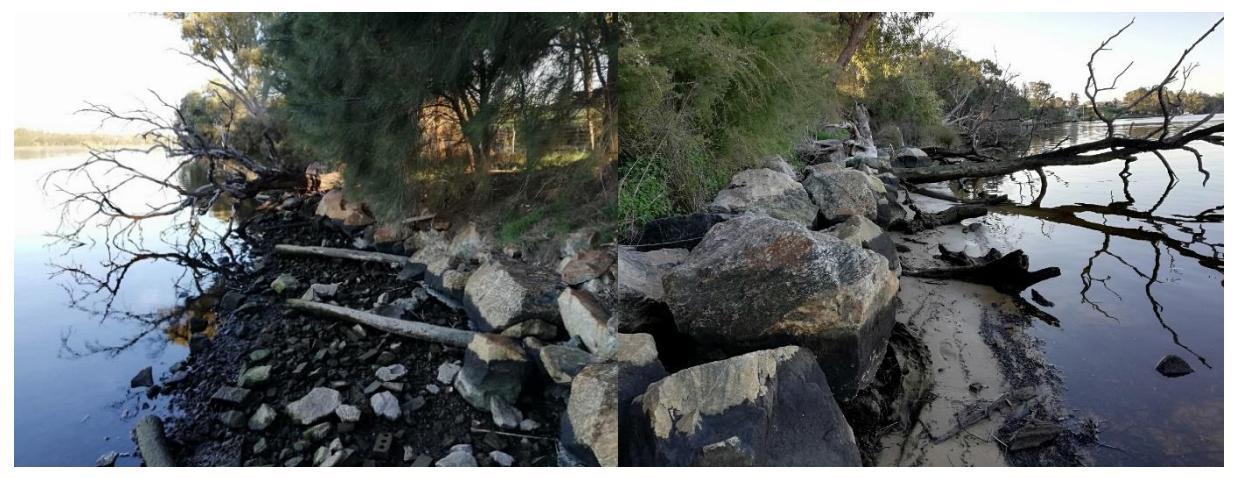
Figure 5.13 Rock Revetments & Dead Trees along the Shoreline

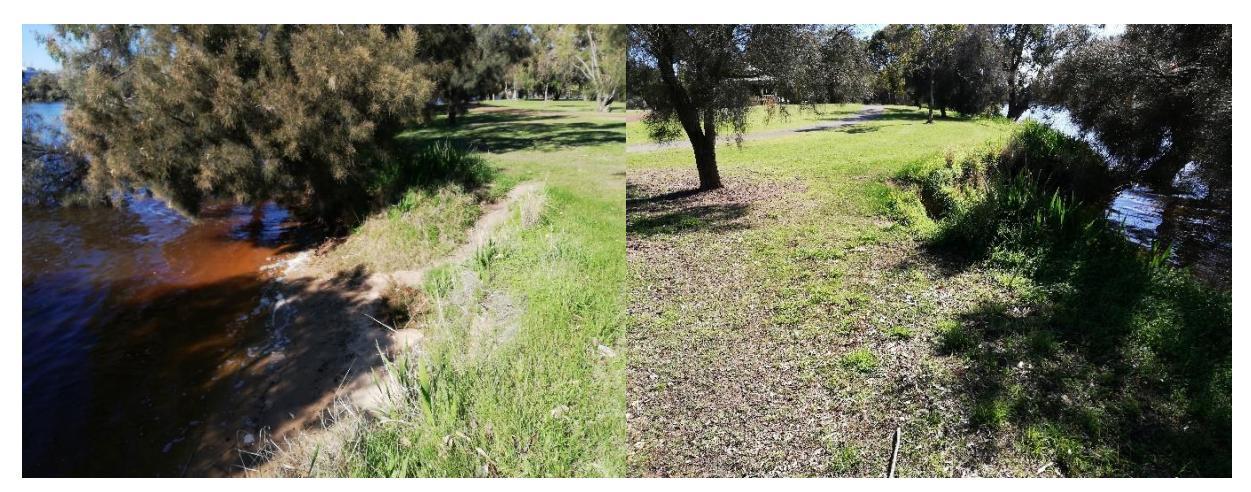
Up to approximately 10 m of erosion has occurred since 1995 in some areas along this stretch of foreshore. Although the erosion has slowed since 2008 in some areas, erosion is likely to continue into the future. This places the footpath at risk.

Figure 5.15 Tranby Reserve Eroded Riverbank

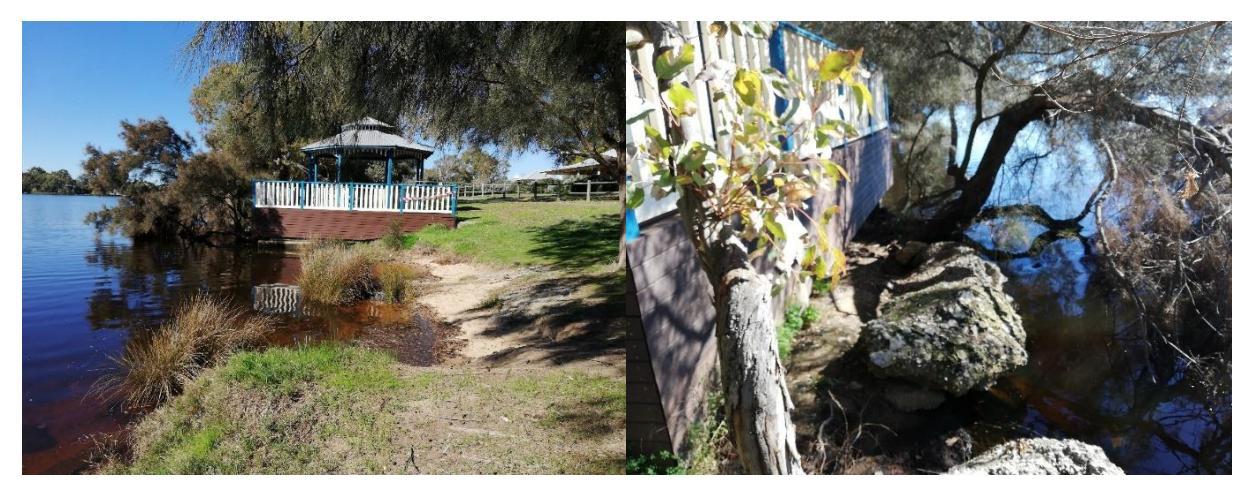
Figure 5.16 Gazebo, Left: Northern Side, Right: Eastern Side

- Barricading off the entrance to structure to prevent public access. The existing warning does not provide a sufficient barrier.
- Undertaking a structural inspection of the gazebo to determine the structural capacity and safety risks.
- If the City wishes to retain the gazebo, undertake:
 - Measures determined by a structural assessment which may include repairs or replacement.
 - Local shoreline stabilisation to prevent undermining.
- Removal of the gazebo, if decided by the City.

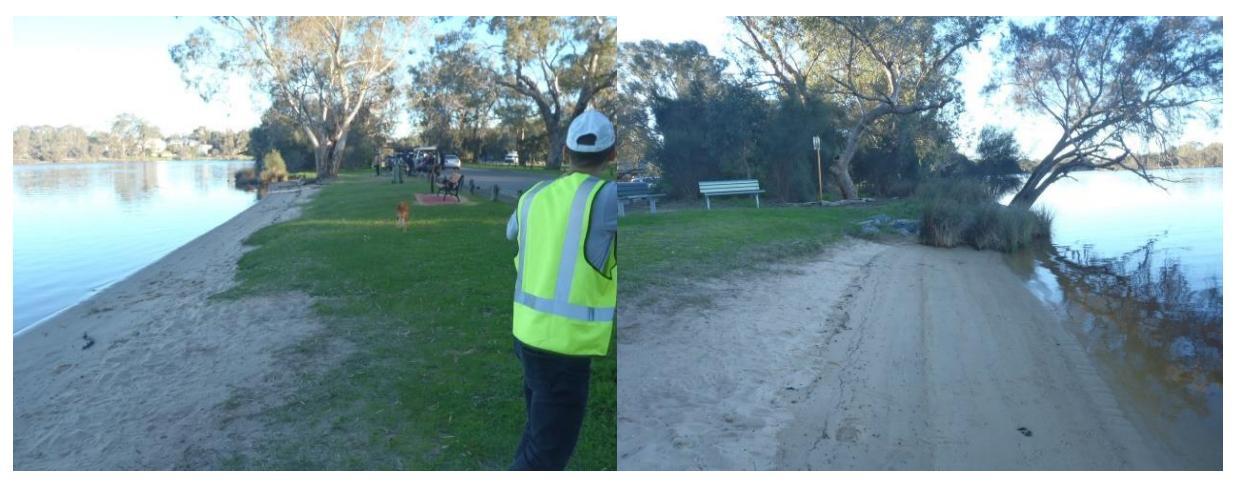
Up to 10 m of erosion has occurred at some locations since 1995. This erosion is expected to continue into the future.

Figure 5.18 Claughton Reserve

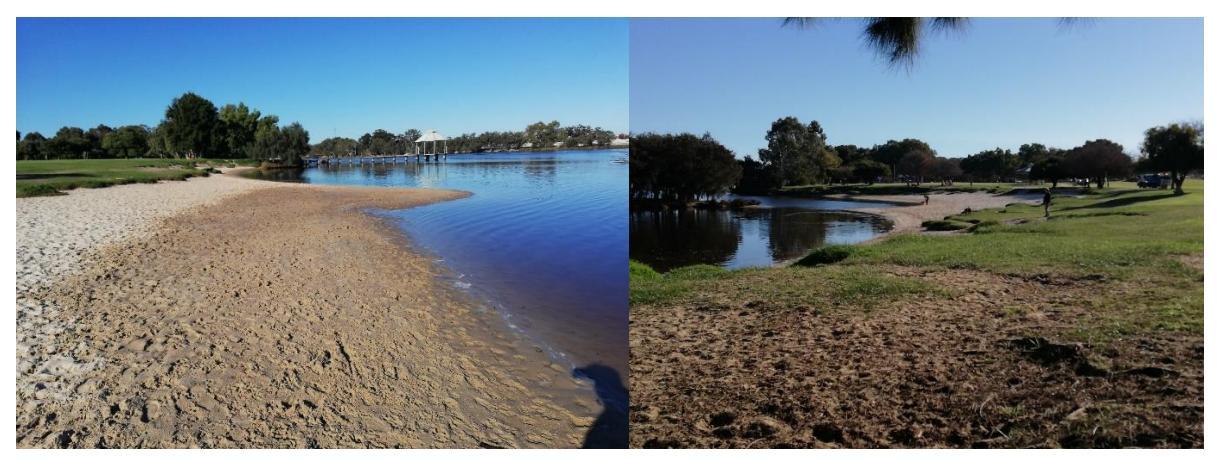
Figure 5.20 Riverside Gardens Beach

In order to provide a budget cost estimate, sand nourishment, replanting of turf and installation of three beach access ramps has been assumed.

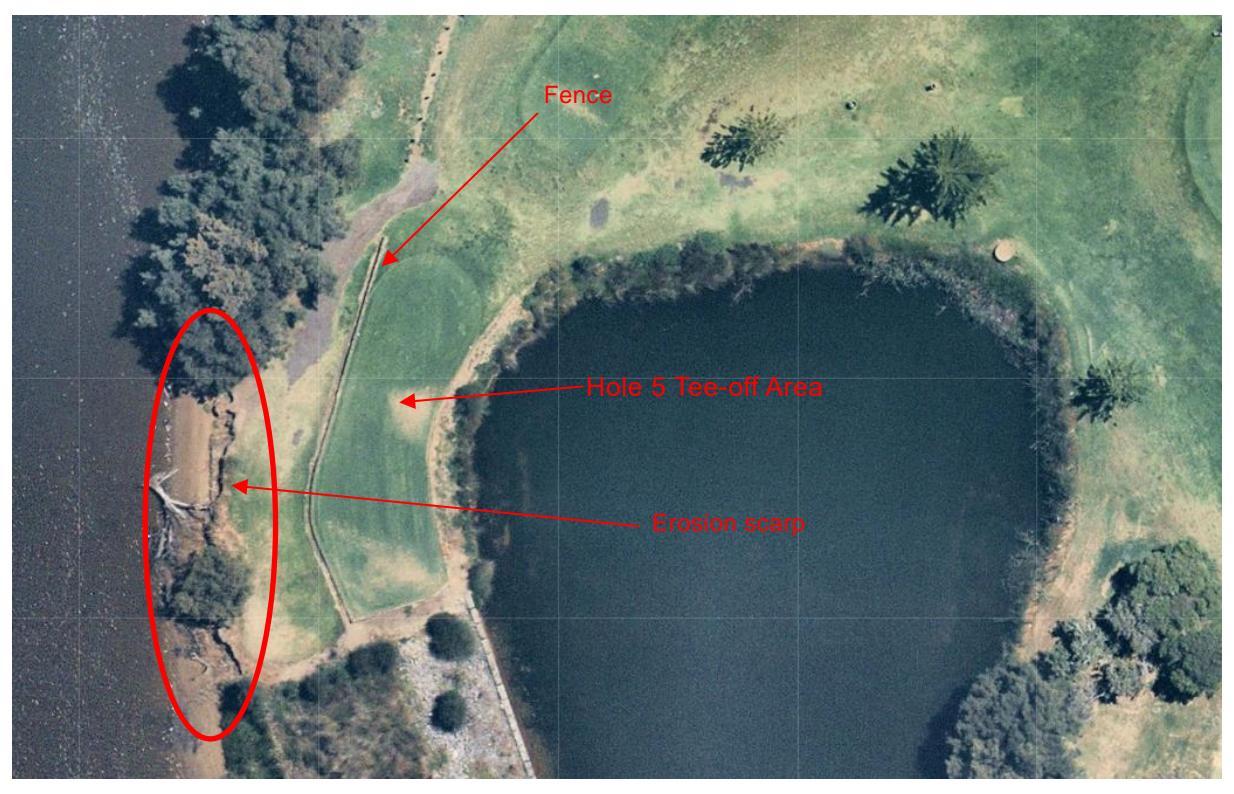
Figure 5.21 Erosion at the Maylands Peninsular Golf Course (Nearmap)

MRA recommends the management of the erosion at Maylands Peninsular Golf Course – Hole 5 include:

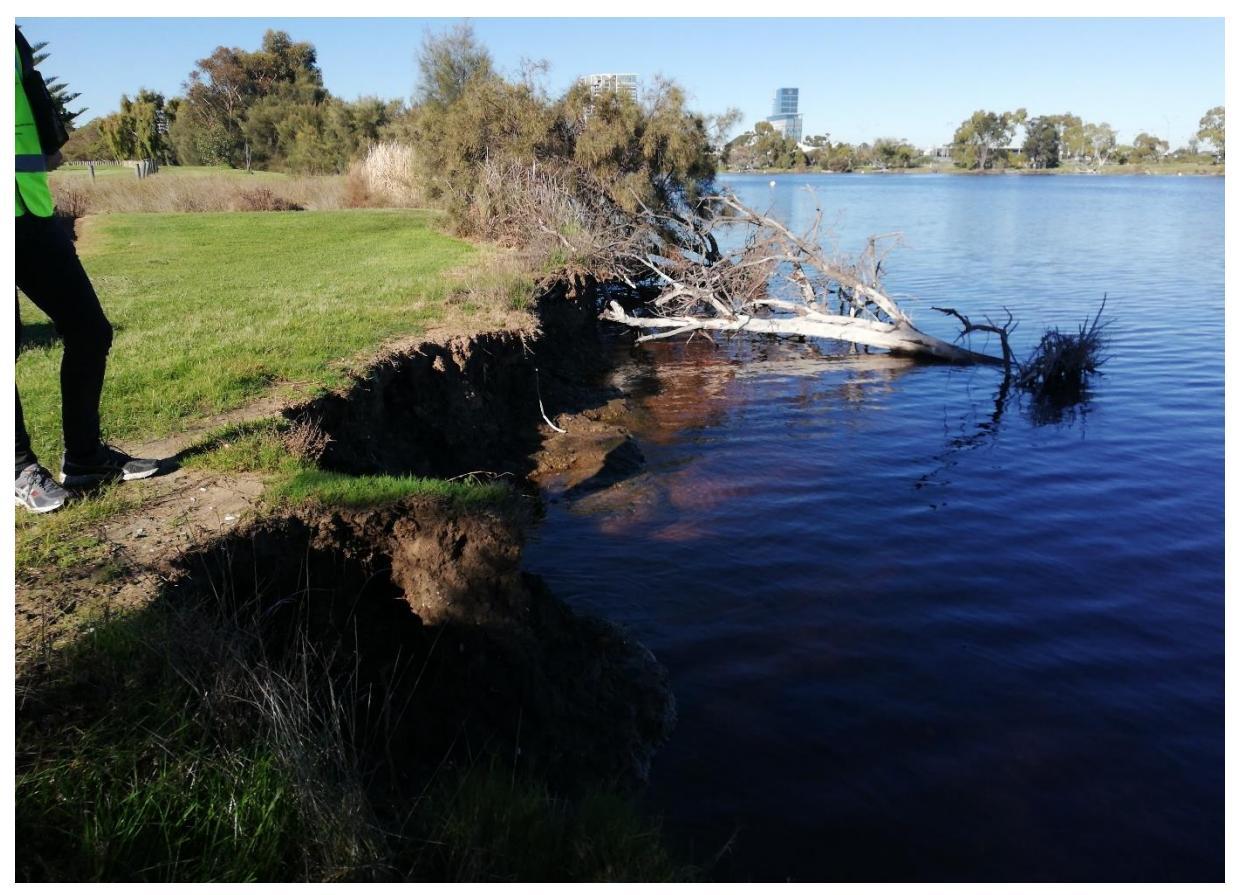
This erosion is likely to encroach towards the Hole 5 Tee-off Area over the next 10 years.

Figure 5.22 Erosion Scarp at the Maylands Peninsular Golf Course – Hole 5

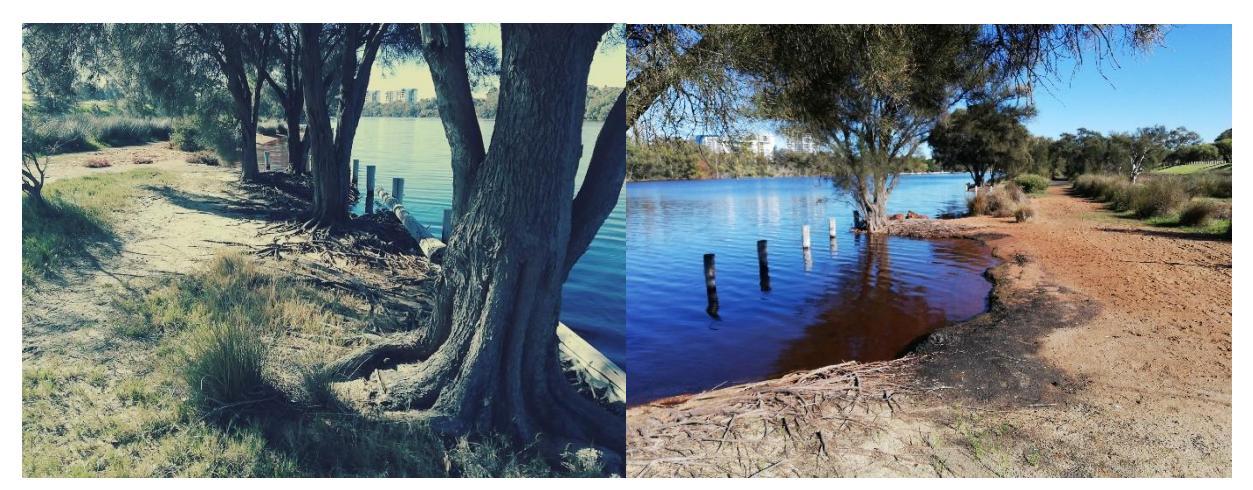
Aerial photography indicates that approximately 3 m of erosion has occurred since 1995. With anticipated loss of these trees, erosion is likely to increase into the future.

Figure 5.23 **Undercut Trees at Maylands Timber Riverwalls**

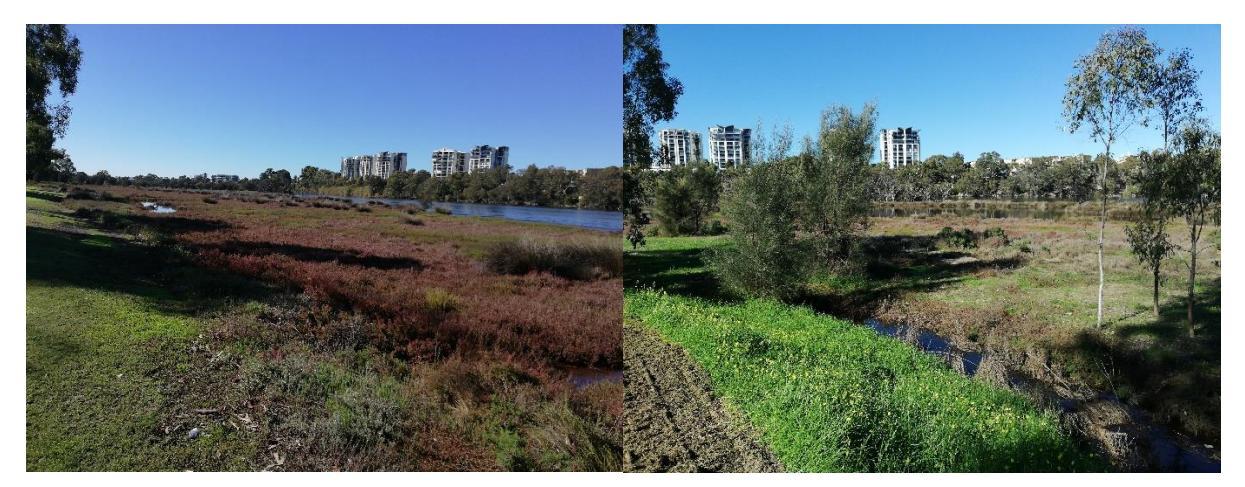
Figure 5.24 Maylands Samphire Flats

Due to the expected continued erosion, MRA recommends that future saltmarsh and samphire preservation efforts focus on areas at least 10 - 20 m inland of the shoreline.

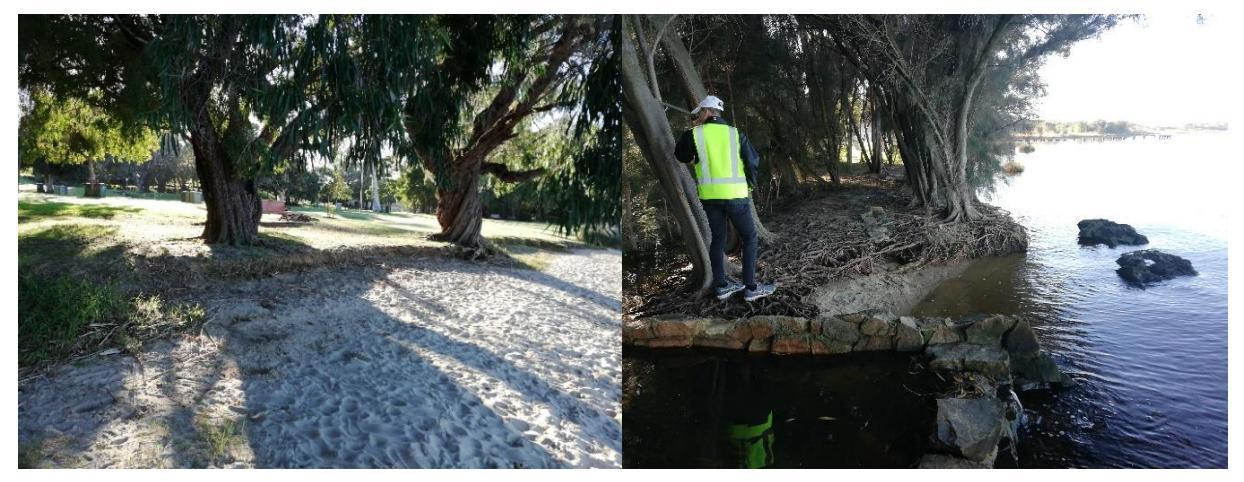
Figure 5.25 Berringa Park At-Risk Trees

Protection of these trees would require stabilisation of the immediate area around each tree. The simplest version of this would consist of small rock protection. An example of this is shown in Figure 5.28.

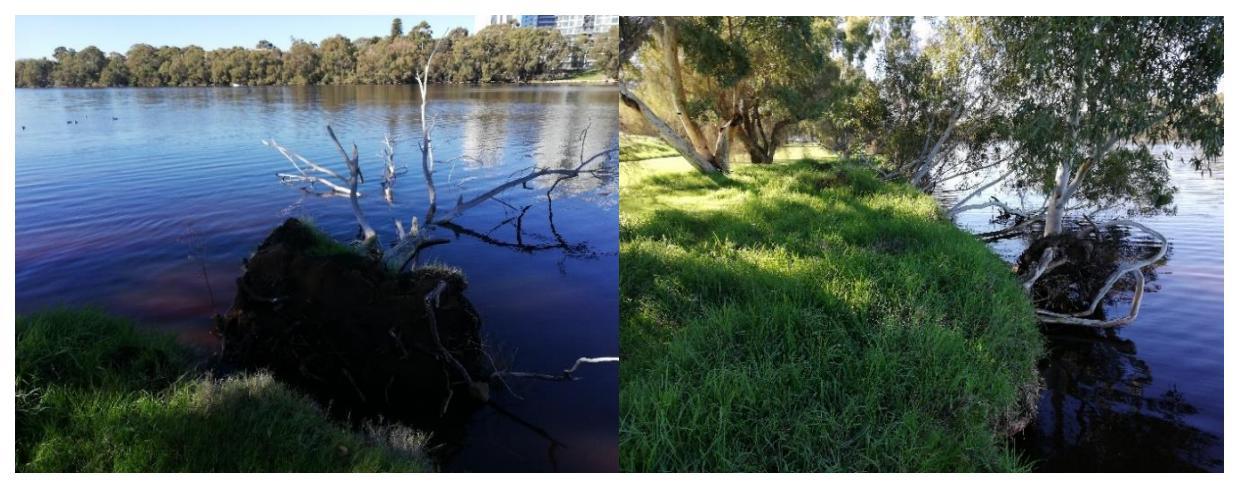
Figure 5.26 Undercut Trees at Maylands Timber Riverwalls

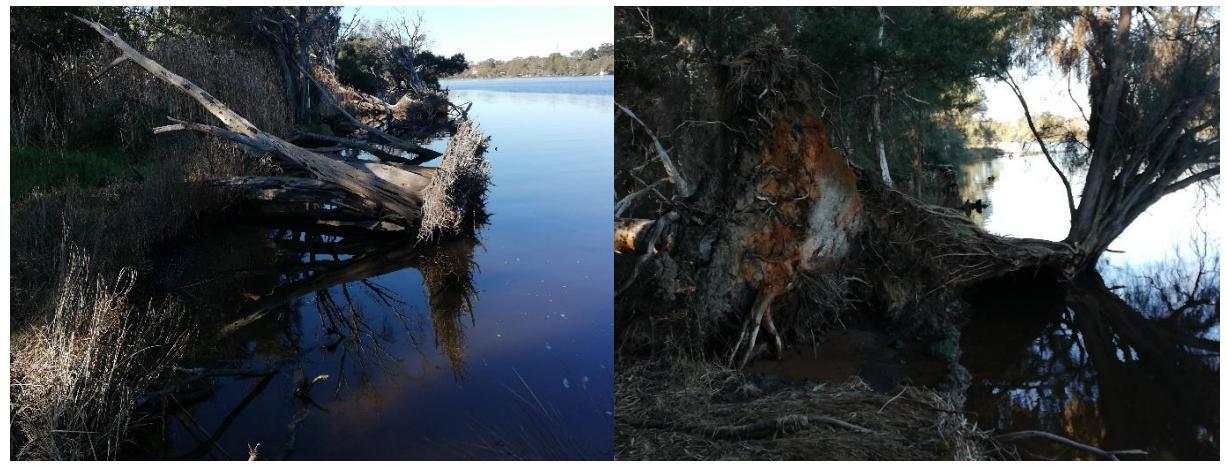
Figure 5.27 Vegetated Shorelines at Hinds Park & Riverside Gardens
