R1245 Rev 0 October 2019 **City of Bayswater Bayswater 2019 Foreshore Inspection** & 10 Year Priority Plan

K1673, Report R1245 Rev 0 Record of Document Revisions

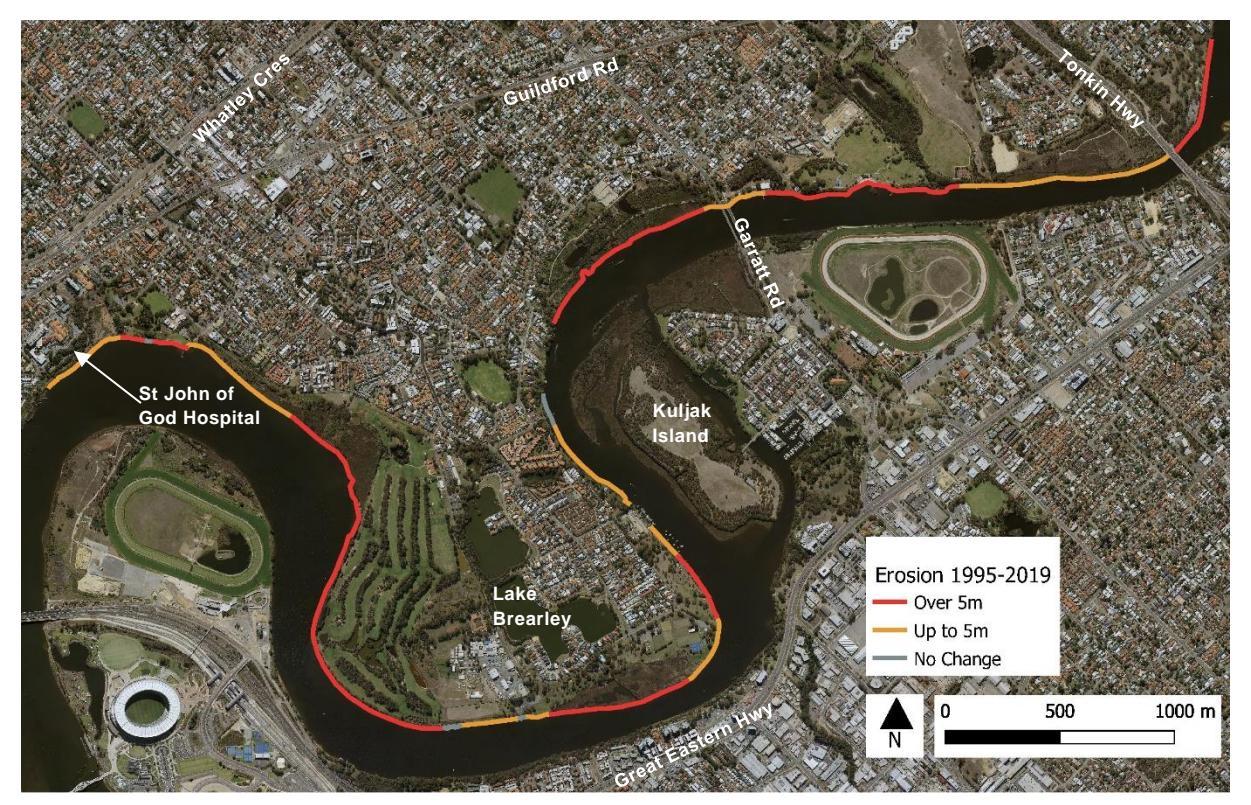
Figure 3.1 City of Bayswater Vegetation Line Movement 1995-2019

Figure 3.1 indicates that erosion of at least 5 m has occurred over much of the City's foreshore. Notable areas of erosion are shown in Figures 3.2 to 3.9.

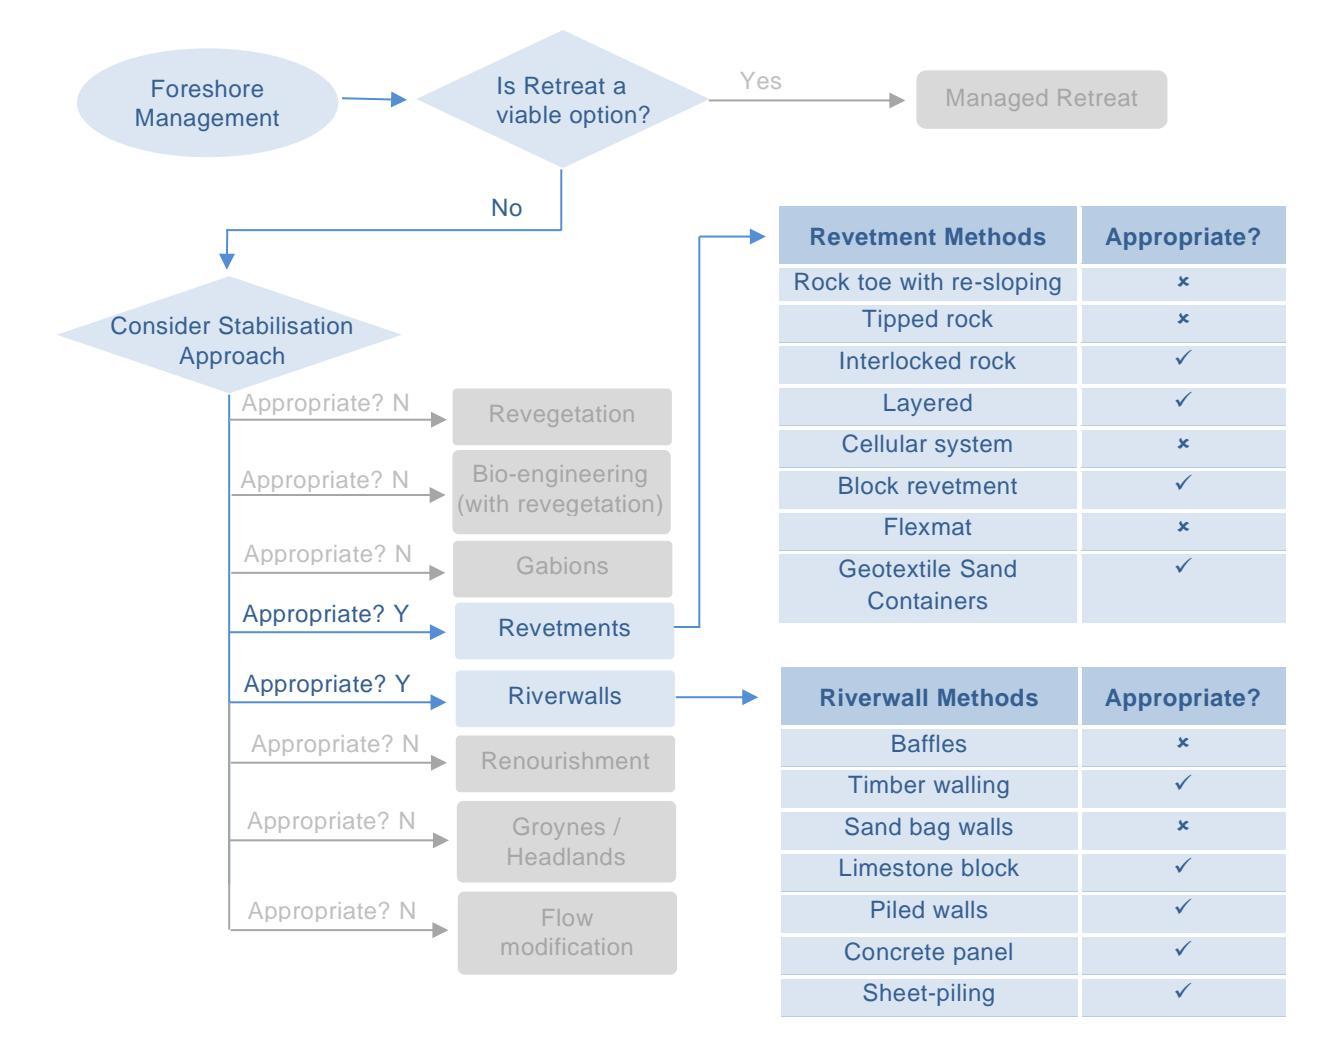
Figure 5.3 Tranby House Reserve Timber Walling –Decision Tree

The Tranby House Reserve timber walling has a combined rating of 25. The critical rating means that actions are recommended within 1 year.

The timber walling is in very poor condition, with many beams falling away from the structure. Sand has recently been placed between the wall and the riverbank. The wall was holding some this material in place at the time of the inspection.

Figure 5.3 indicates that a revetment or riverwall would be an appropriate stabilisation option. MRA recommends the foreshore stabilisation at the Tranby Reserve North Timber Walling include:

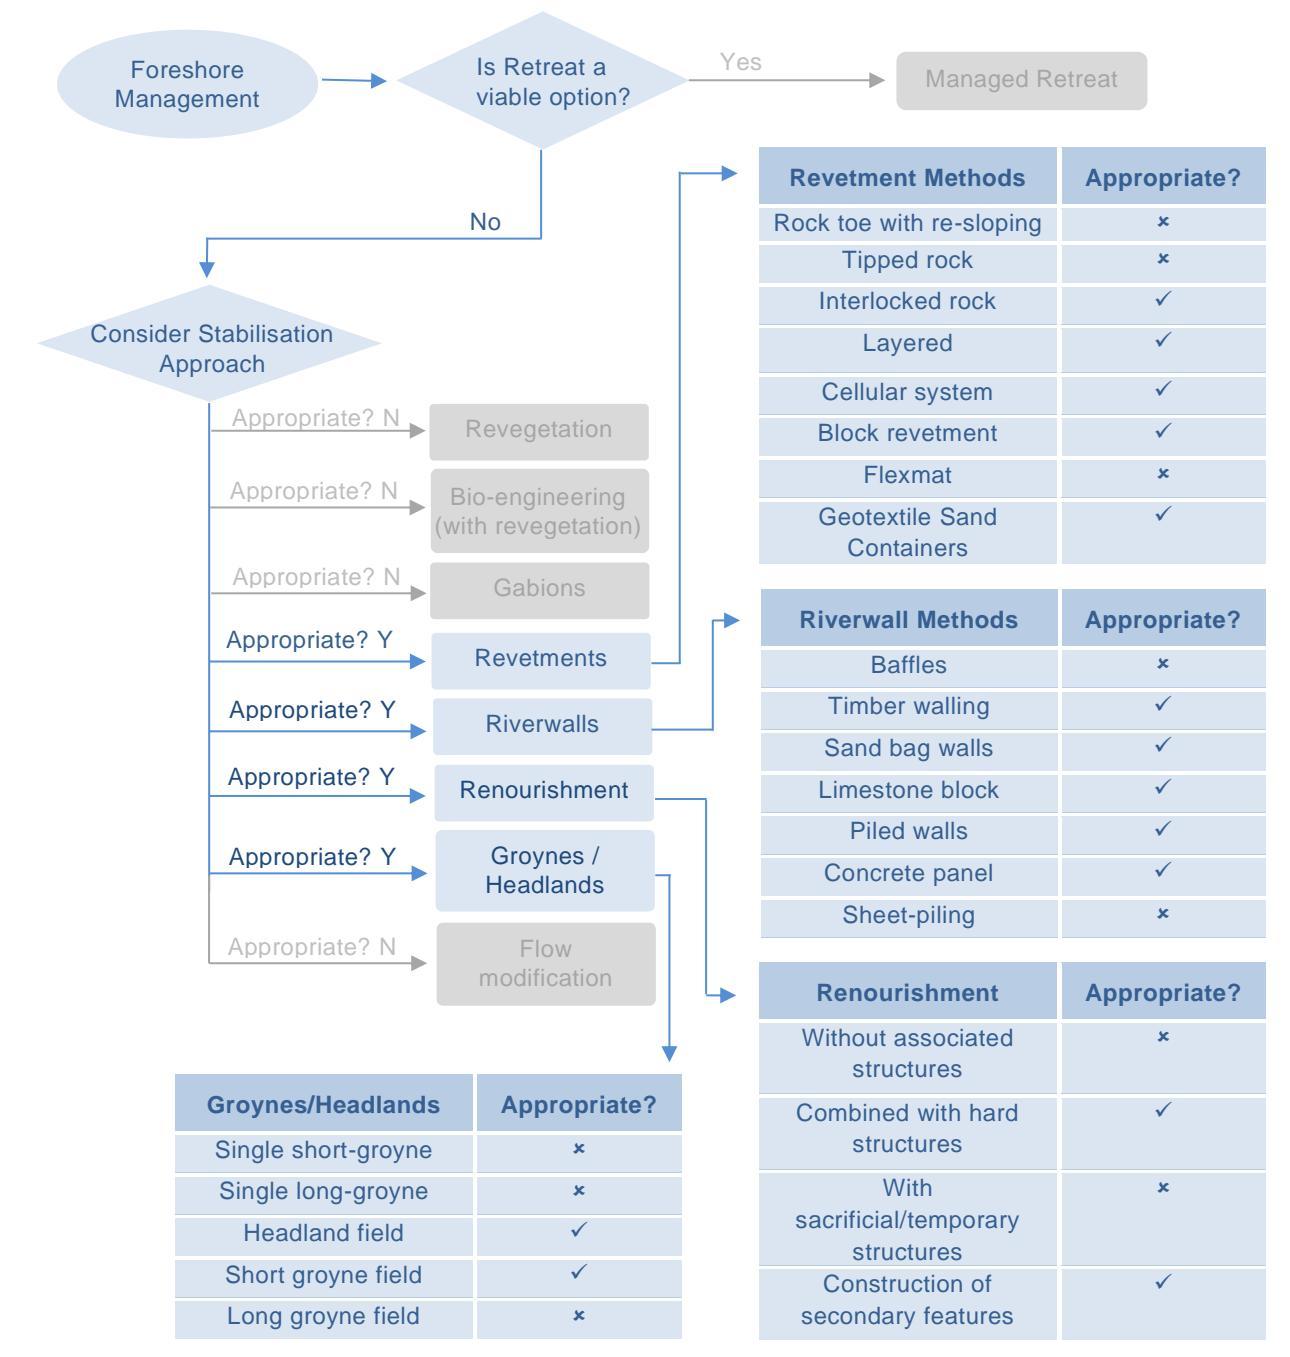
Figure 5.10 Hinds Park Decision Tree

A decision tree for management options at Hinds Park is presented in Figure 5.10. The figure indicates that a range of stabilisation options would potentially be appropriate.

Although stabilisation is recommended the entire stretch of Hinds Park, the repairs and upgrades to the block wall are a higher priority than stabilisation of the shoreline. Repairs to the block wall are recommended within the next 1 - 4 years. Hence the City could initially repair the block wall independently to the rest of the area.

In addition to stabilisation, MRA recommends that the City consider removing the rubble and debris from the shoreline in front of the Sea Scouts Hall.

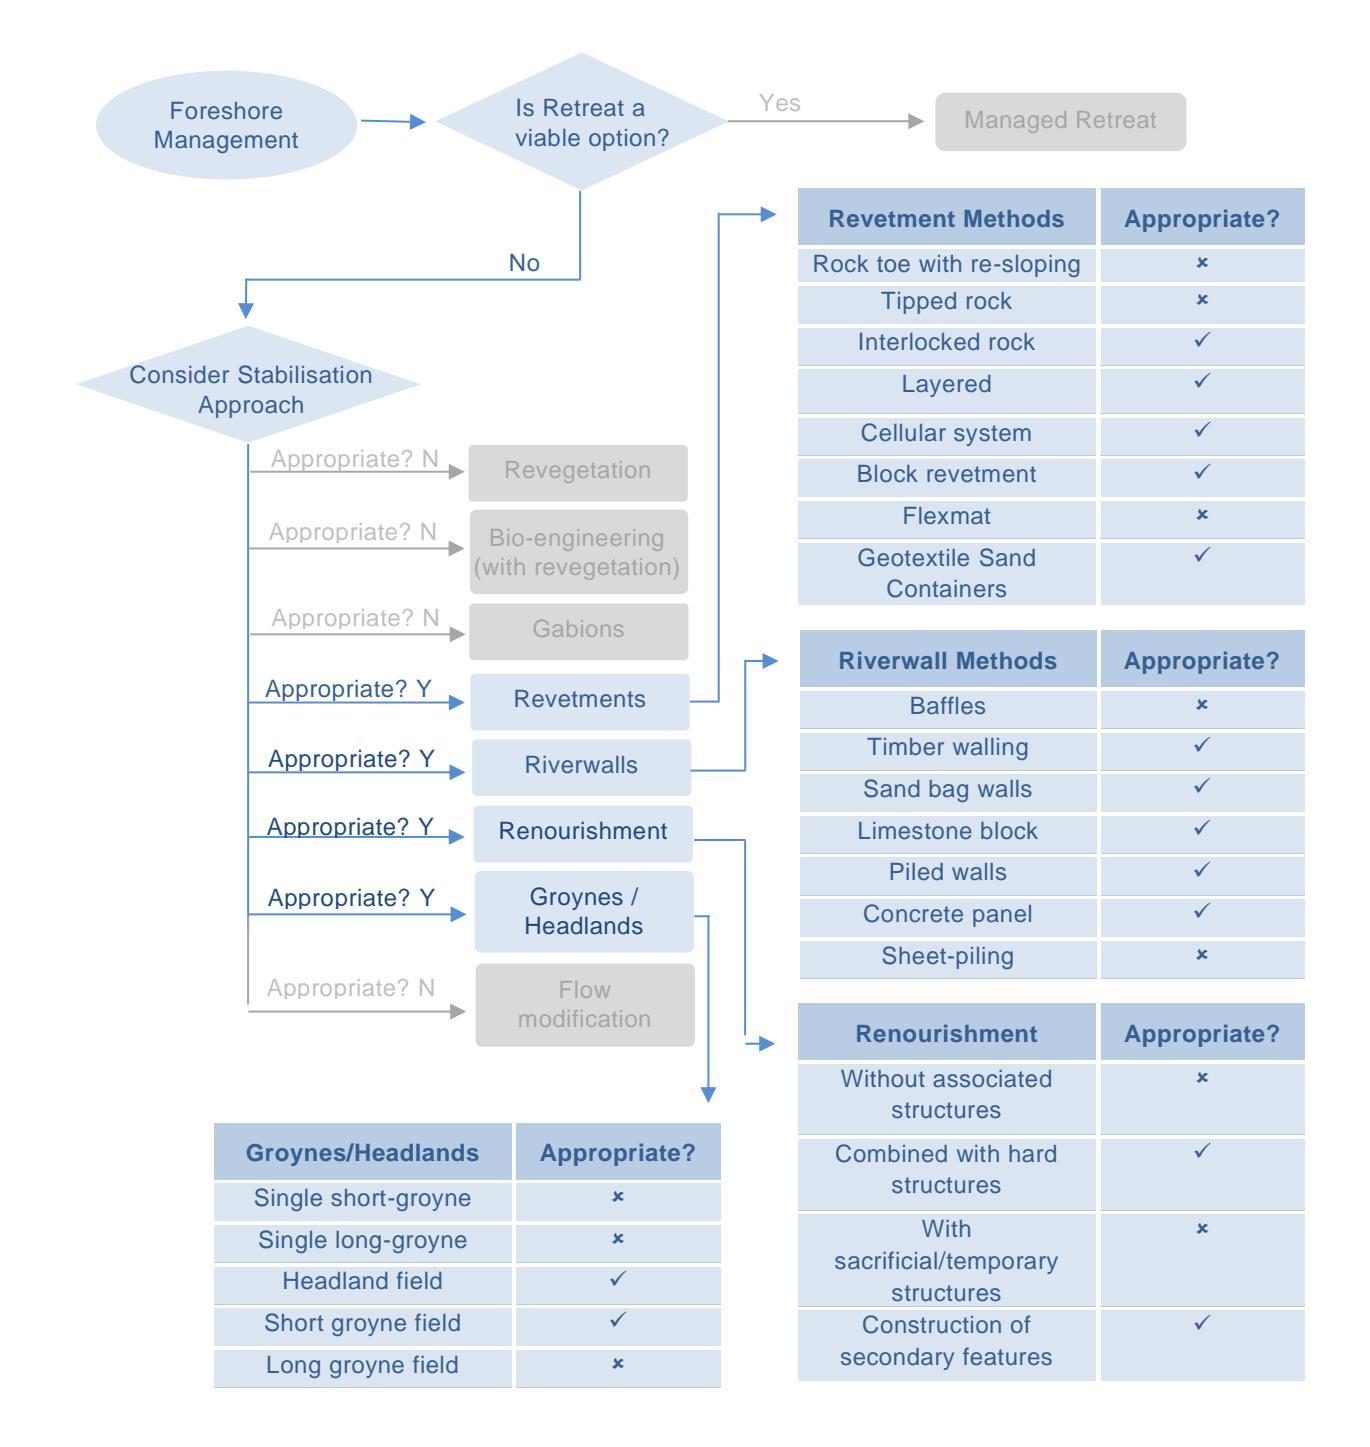
Figure 5.19 Claughton Reserve Decision Tree

A decision tree of management options for Claughton Reserve is Figure 5.19. The figure indicates that a range of stabilisation options could potentially be appropriate.

- Sand nourishment.
- Up to three nodal headlands (rock protection) along the shoreline to protect the existing trees hold the sand in place
- Revegetation of the riverbank.

Given that some stabilisation and revegetation has already been carried out on the site, this appears consistent with current measures accepted by the City and DBCA.

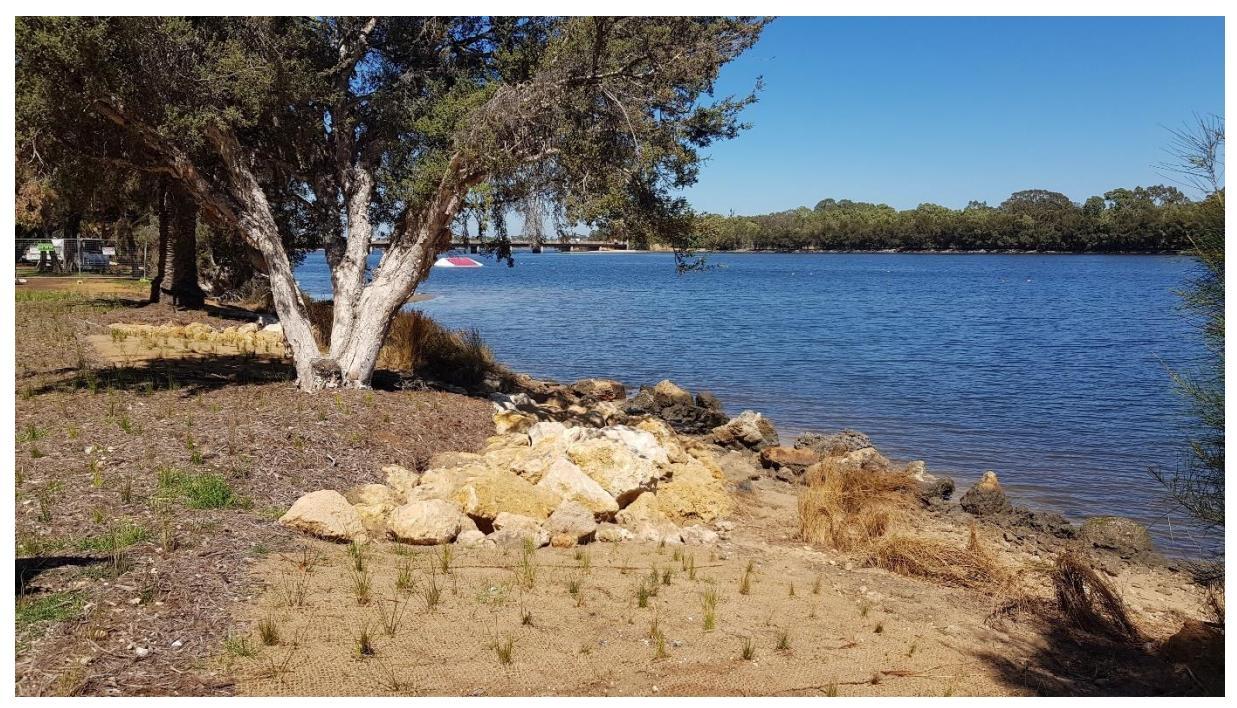
Figure 5.28 Localised Tree Protection Example

Protection of these trees would require stabilisation of the immediate area around each tree. The simplest version of this would consist of small rock protection. An example of this is shown in Figure 5.28.

In addition, tree replacement and revegetation is recommended to offset losses and improve stabilisation.
